# Looe Heritage Guidance Notes

## No. 1: Shopfronts and Signage

*These Guidance Notes have been produced by Caradon District Council as part of the Looe Heritage Economic Regeneration Scheme (HERS). The views expressed are intended to stimulate discussion and the adoption of positive approaches in the town.*

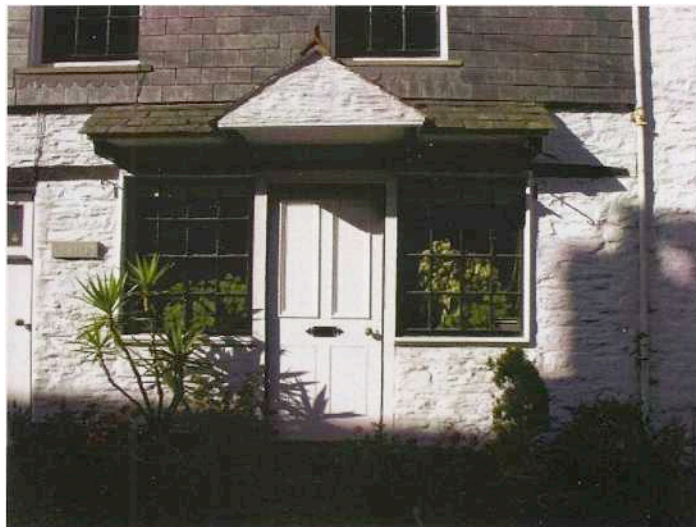
*Fig 1: A charming shopfront of the later 18th or early 19th century*

During the 18th century the shopfront became an essential element of the townscape and there were plenty of shops in both East and West Looe at this time. Initially they took the form of enlarged windows with a clear association to domestic windows of the time. *[Fig 1]*

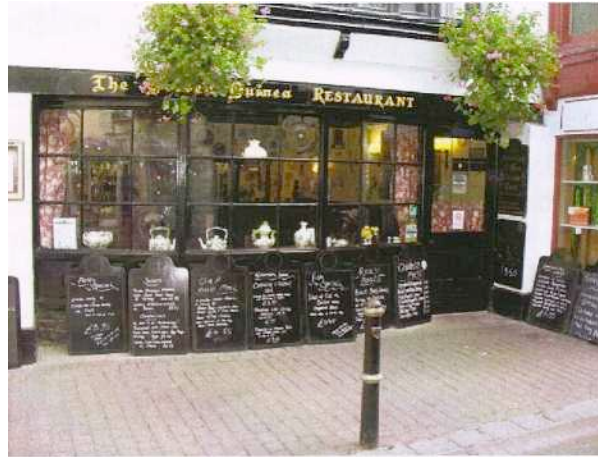
*Fig 2: The Georgian pattern of glazing here sits on a later panelled stall riser that is obscured by temporary signs*

Before long pretty much the whole of the ground floor of many buildings became glazed to the street. Glass was very expensive though, and could not be manufactured in large sheets, so Georgian shopfronts were divided into the same multiple panes as the windows. *[Fig 2]*

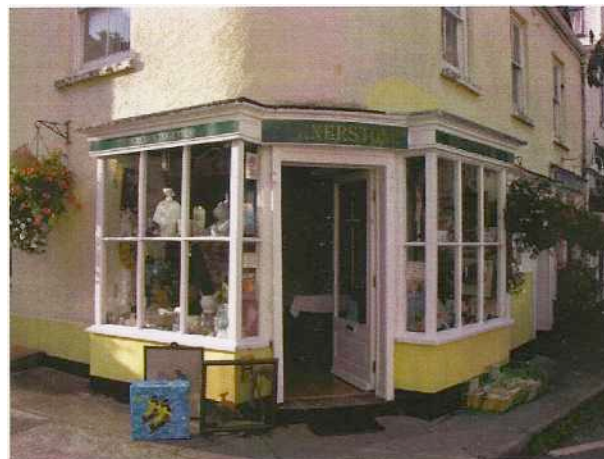
*Fig 3: Larger sheets of glass were still used in a traditional configuration, simply with larger glazing bars*

It was not until later in the 19th century that this revolutionary product became available and affordable in places like Looe. The shopfront was, however, the main way for a business to advertise itself and traders would try to obtain the highest quality of materials and detailing they could afford. Larger sheets of glass meant fewer glazing bars. [Fig 3]

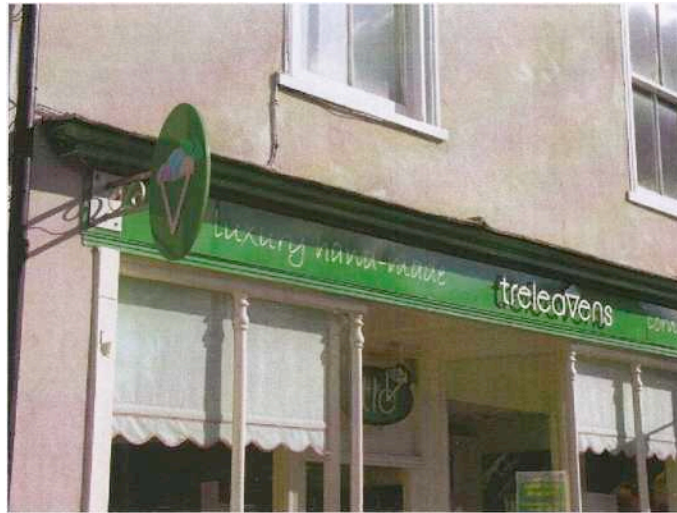
*Fig 4: Mullions often had decorative capitals and bases*

Lower stall risers and millions or columns became a more important element of the composition, with decorative flourishes. [Fig 4]

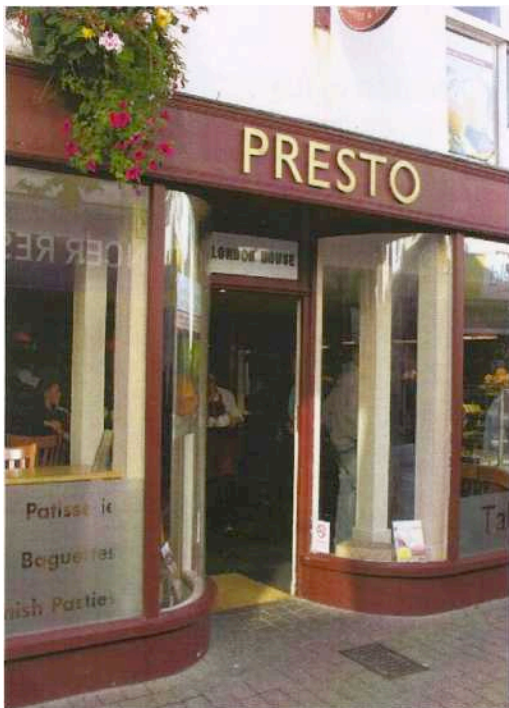
*Fig 5: Curved plate glass was a technological advance*

Towards the latter part of the 19th century the use of hardwood for turned and decorated mullions became a more common sight. Curved glass began to be incorporated into designs that invited shoppers in and offered display spaces that were an attraction in their own right. [Fig 5]

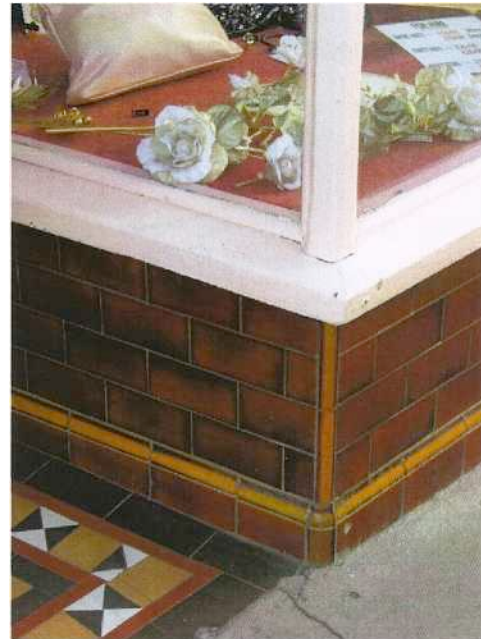
*Fig 6: Decorative floor tiles and glazed die stall riser add richness to the streetscene*

This increasingly applied to the floorscape as well, with encaustic tiles, mosaics or engraved stone being used for thresholds. [Fig 6]

In Looe the finish for stall risers is most commonly render, though ceramic bricks, [Fig 6] tiles and stone may have been more common in the past. Occasional quirky features may reflect the personality of an individual and where they exhibit craft skills they add to the sense of place. [Fig 14]

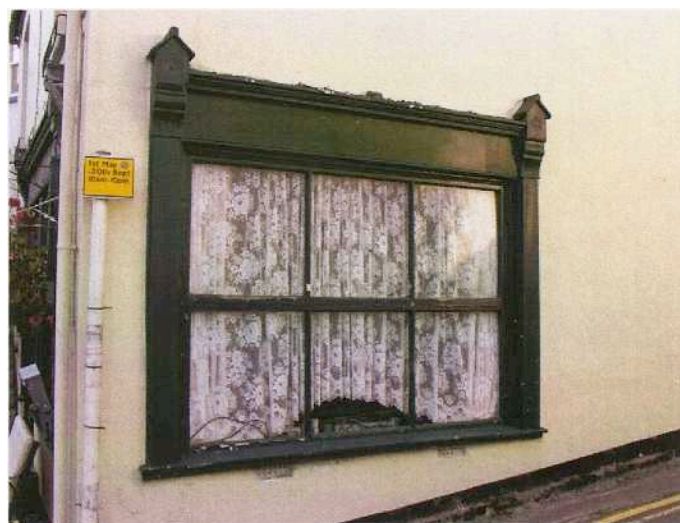
*Fig 7: Shopfronts contribute to the townscape character even if they no longer serve their original purpose*

A number of smaller shop units have been converted to full residential use, especially in West Looe, though some have successfully retained their shop windows. [Fig 7]

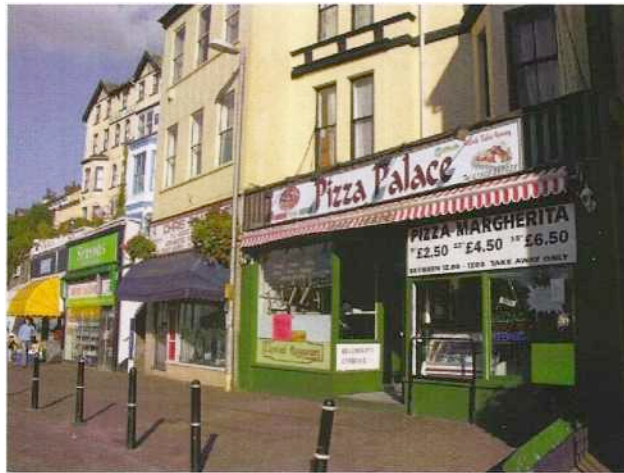
*Fig 8: This chaotic scene occupies the vital entry point to the town centre*

Many of the remaining shops have had their frontages altered or replaced with a general loss of character. Blanked off windows may allow more shelf space but they offer nothing to the streetscene; plastic dutch blinds obscure and confuse the appearance of some shopfronts. A legacy of haphazard shopfront design, poorly detailed joinery and inconsiderate signage is all too apparent in Looe. [Fig 8]

the result is detrimental to all [see Fig 8]. When this inconsiderate treatment marks the approaches to the town centre the negative impact is felt even more widely.

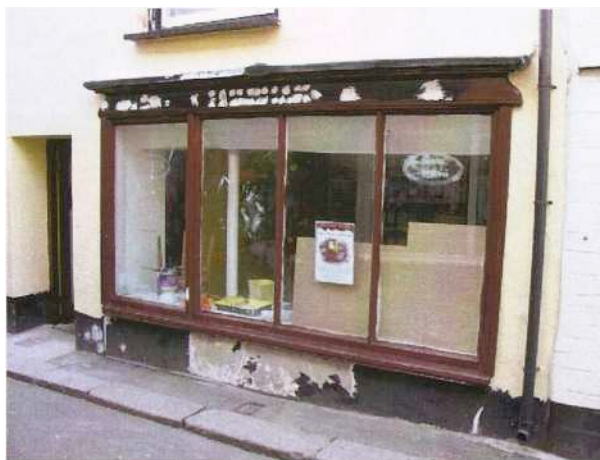
*Fig 9: This traditional historic shopfront is being repaired and refreshed ready for more years of service*

The reinstatement of lost features and authentically detailed or well designed contemporary shopfronts is very desirable. This is not driven by a naive fondness for the past; there is strong evidence to show that historic towns with a high proportion of traditional and well kept shopfronts tend to have a sounder economic base. [Fig 9]

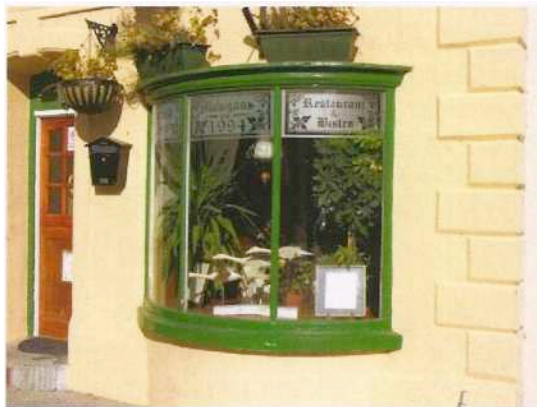
*Fig 12: Unusual designs demand creative signage solutions*

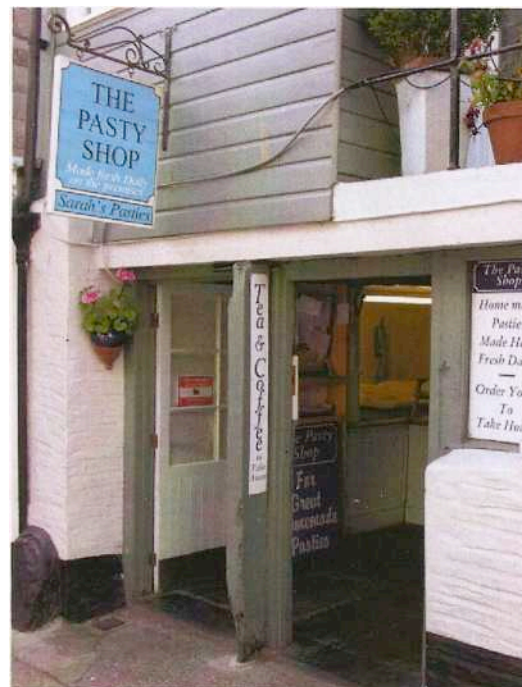
*Fig 13: Informal evolved units also need thoughtful signage*

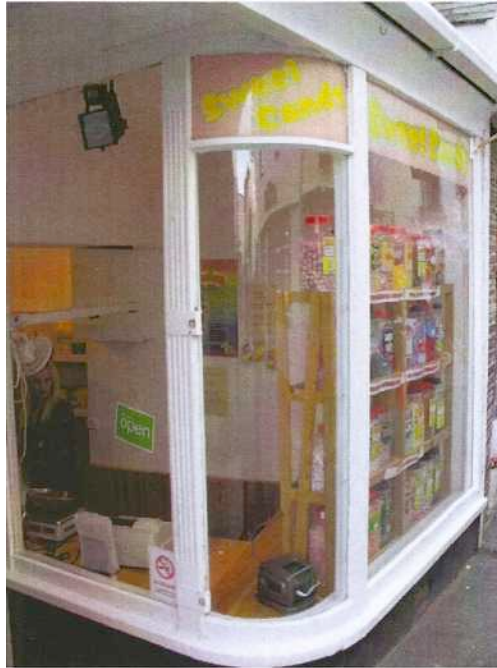
*Fig 15: Flat mullions fluted in the style of pilasters*

Shopfront sills were usually significantly deeper and more substantial than domestic ones; they often incorporated decorative moulding to add visual interest, [eg. Fig 15]

The vertical and horizontal elements of a traditional shopfront usually incorporate a moulded detail of some kind. In Looe this is usually quite plain but even a simple moulding uses light and shade to create interest. Mullions and frames may be embellished with decorative bases and fluting; in the past these may have been picked out as part of a decorative scheme. [Fig 15]

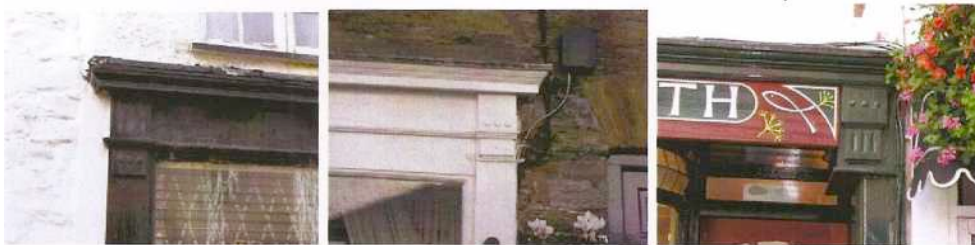
*Figs 16, 17 & 18: Simply decorated corbels, supporting modest entablature, are found throughout the town*

The pilasters frame the shopfront and visually support the fascia. They may be plain and simple or quite decorative, but they will normally reflect the principles of classical entablature by incorporating base and capital. Sometimes the capital takes the form of a plain or decorative corbel that supports a moulded cornice. Variations on a similar theme are a feature throughout Looe. [Figs 16, 17 & 18]

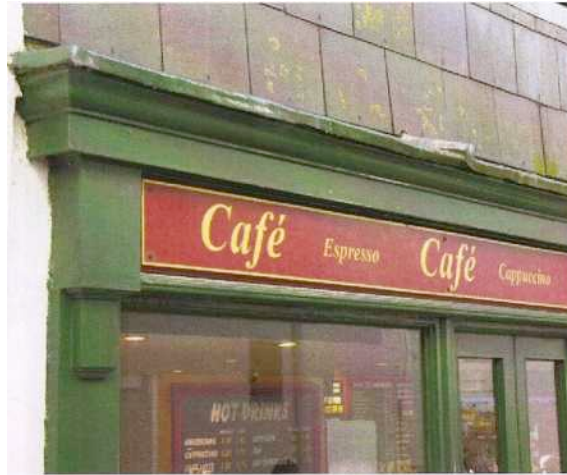
*Fig 19: Even a simple entablature creates depth and interest, though here that depth is diminished by the applied fascia sign. It is better to have signage painted directly onto the fascia itself.*

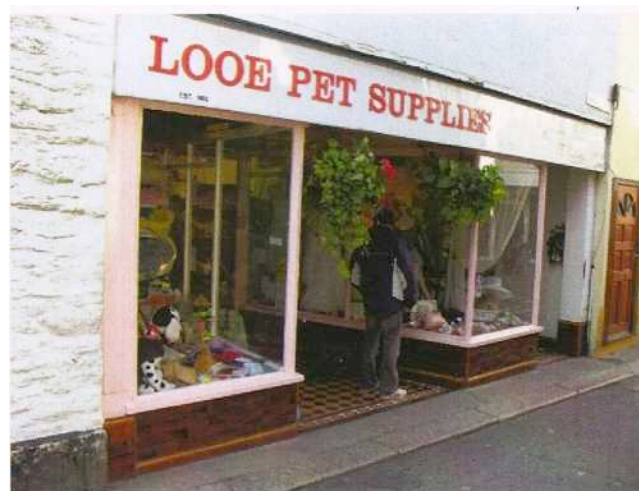
*Fig 20: An historic recessed entrance. (The plastic sign board here probably covers the original timber fascia that could be restored)*

Many shopfronts would have a recessed entrance, sometimes called an in-go. [Fig 20] This would draw customers in from the street and added to the quality of display space. Occasionally there may be expensive curved glass to attract the interest of passing pedestrians; it also offered shelter from the elements. Additional interest was often added in the form of a quality threshold; sometimes this could be a stone slab but often it would be decorative tiles or a mosaic which could include the name of the shop.

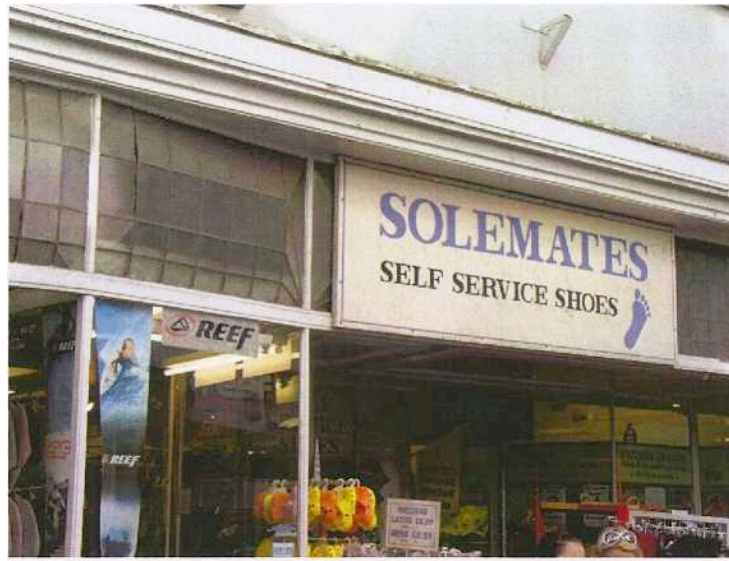
*Fig 21: This 20th century leaded glass has bulged due to poor installation and maintenance but could be restored*

Metals were sometimes used for window frames or decorative mullions in the past - from ornate Victorian cast iron to sleek art deco bronze - but these are not found in Looe so there is no justification for their introduction. Lead flashings are an important feature though and they need to be carefully considered. Existing flashings above fascias and cornices are often punctured by careless electrical or telephone installations and poorly executed repairs. This leads in turn to water penetration and, inevitably, rotten timber. Leaded glass is an occasional feature from a range of dates and can add variety to the streetscene. *[Fig 21]*

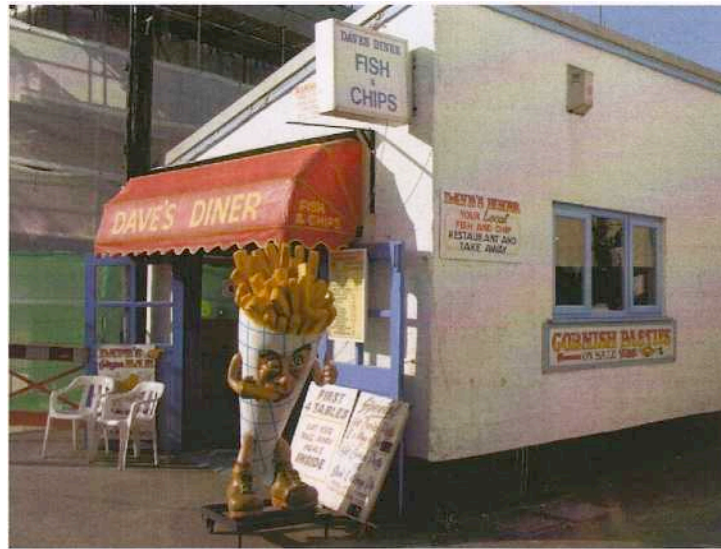
*Fig 22: A lack of historic character can offer an opportunity for something different. In this instance, as elsewhere in Looe, less signage may have more impact if it is well designed.*

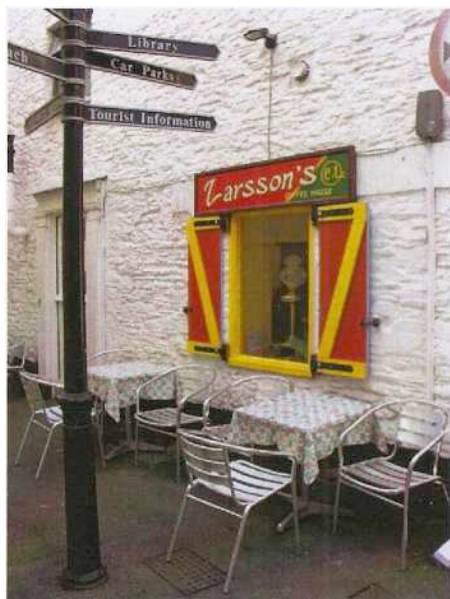
*Fig 23: These shutters are eye-catching but are they necessary?*

Whilst security is a serious issue for some types of business, it is important that any measures do not dominate the character of the shop unit. Off-the-peg security shutters or grilles are not an acceptable solution externally. Laminated glass, although expensive, does provide a good alternative. If the need for extra security is clearly demonstrated then an internal grille may be acceptable in some instances. Timber shutters were sometimes used historically and may occasionally find a use today, though the justification and detailing need to be strong. [Fig 23]

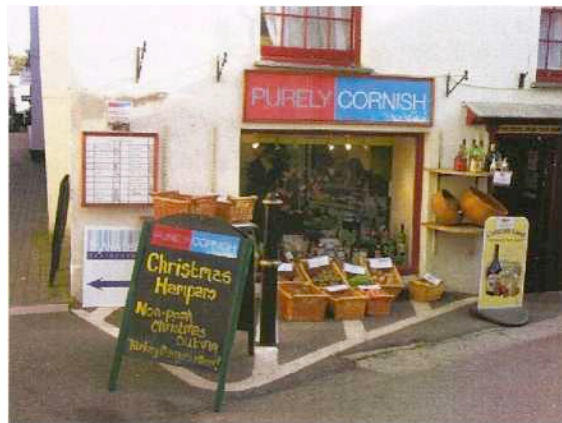
*Fig 24: The produce on display here is undermined and obscured by the extra signs.*

The way in which shopkeepers use their premises to address the street is another important factor. The ephemeral art of shop window and pavement displays can add hugely to the character of a place. [Fig 24] This ostensibly 'old-fashioned' approach can engage and intrigue passing customers if it is done well. All too often though the option of more and more 'temporary' signs is favoured and in Looe it is fair to say this has reached epidemic proportions.

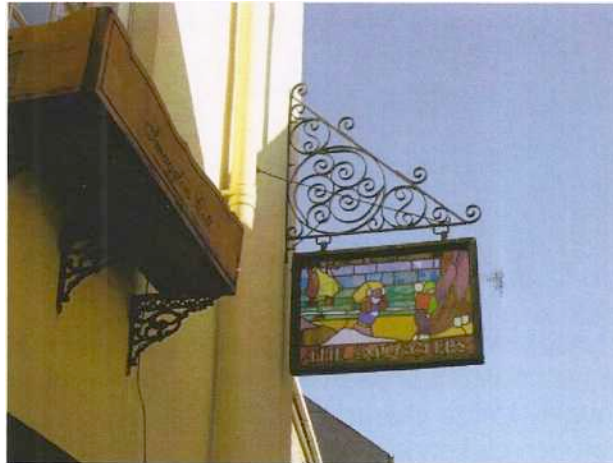
*Fig 25: A hanging sign that exhibits the value-added quality of a one-off commission*

By comparison, carefully considered signs that demonstrate a degree of artistic input and the use of durable high quality materials are more likely to attract passing trade. [Fig 25]

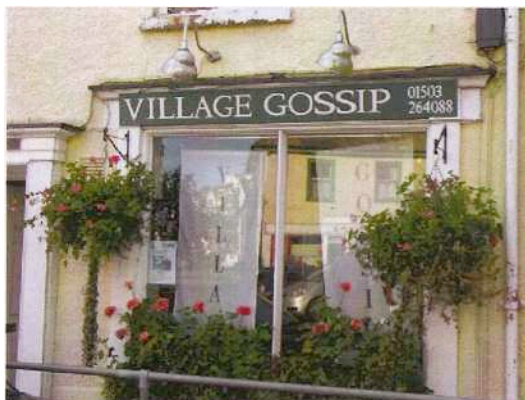
*Fig 26: Has any advantage been gained here by applying a fascia board that overlaps the cornice and pilaster capitals? The light units are also poorly designed, oversized and probably unnecessary*

The fundamental issues are the size and form of the signs themselves, (whether fascia, hanging or projecting), [Fig 26] and the graphic or artistic quality of the actual signage. It can be really helpful for signage to in some way reflect the business that is being advertised. [Fig 27]

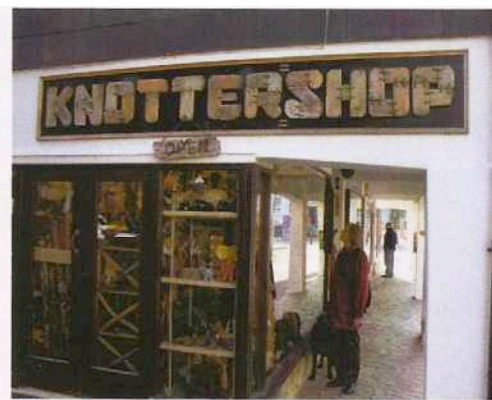
*Fig 27: A simple and effective sign relates to the business well*

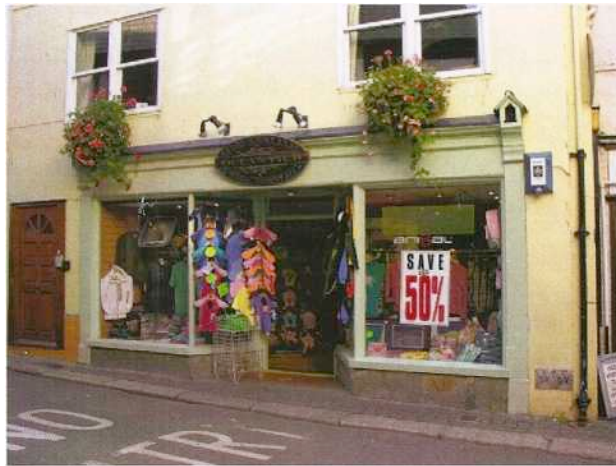
*Fig 28: Whilst the oval sign is unusual, a better solution would have been to use the existing fascia for the shop name. The lighting, however, is not needed and detracts from the appearance of the whole building*

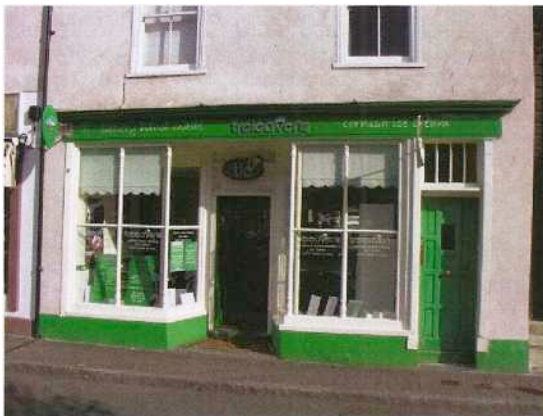
*Fig 29: The lettering used here is visually lightweight but effective; despite the repetition of content, the scale and font do not dominate the building. The shopfront itself can be enjoyed in its own right as all of the detailing is visible*

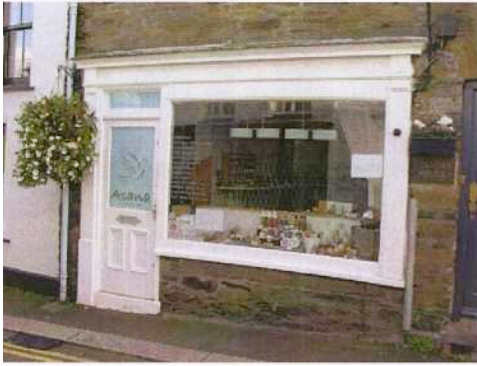
*Fig 30: The fact that this signage whispers to the passer by instead of shouting seems to reflect the nature of the business*

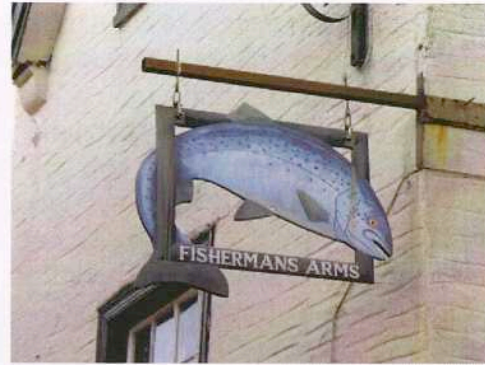
*Fig 31: A simple graphic hanging sign on a functional bracket says all it needs to*

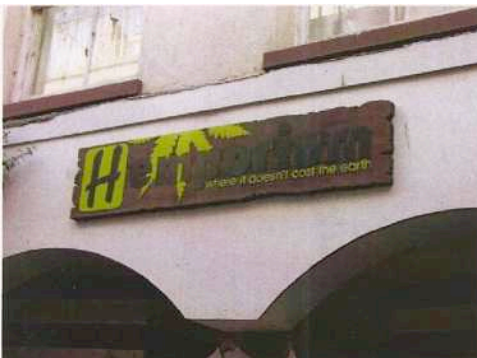
*Fig 32: Although there is no fascia here the temptation to fill the available space is resisted and such modesty respects the historic setting*

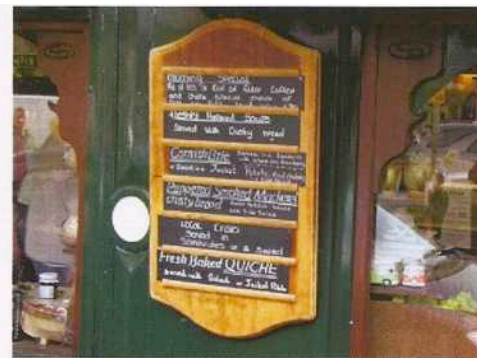
*Fig 33: A versatile menu board that does all it needs to in the narrow medieval street scene without causing visual clutter or obstruction*

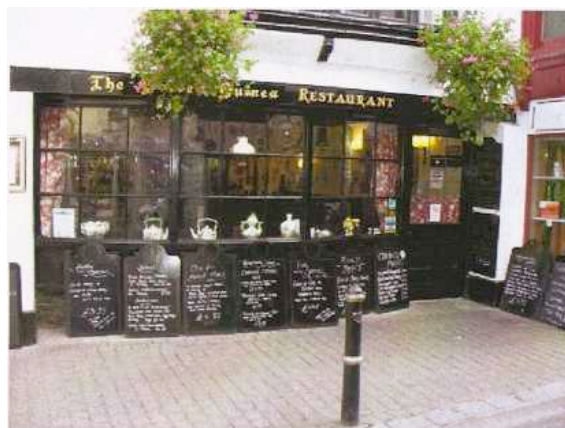
*Fig 34: The wall mounted blackboards are surely enough? The unfixed menu boards simply add clutter and detract from the historic building*

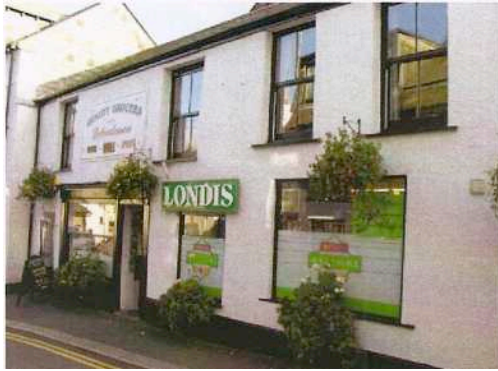
*Fig 35: The traditional shopfront is very attractive, with a massive sash window that formerly allowed produce to be openly displayed to the street. By comparison the corporate branding of this local convenience store is clumsy and quite unnecessary*

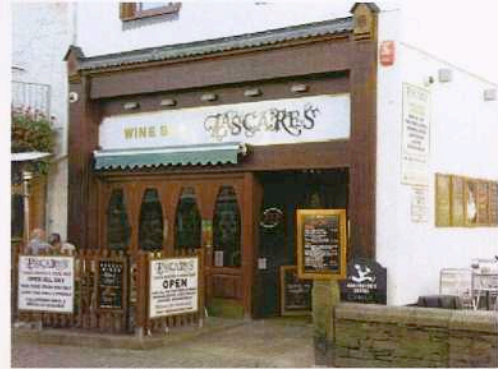
*Fig 36: The scale and proportion of the frontage is overbearing while the number of signs is confusing and incoherent*

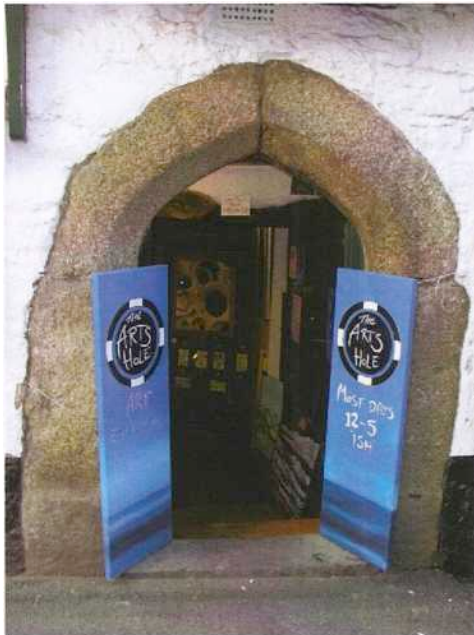
*Fig 37: These signs obscure an important historic doorway and are also a physical obstruction*

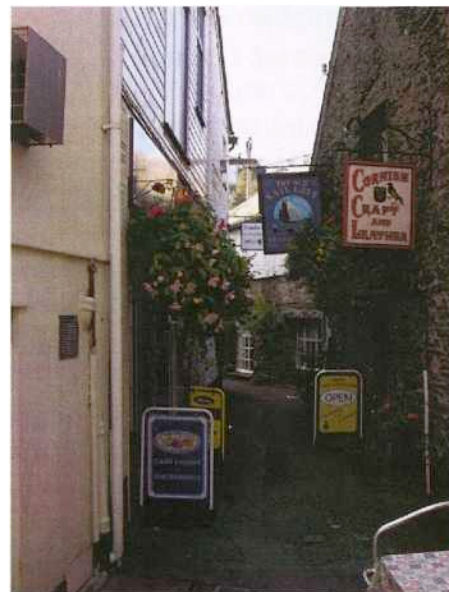
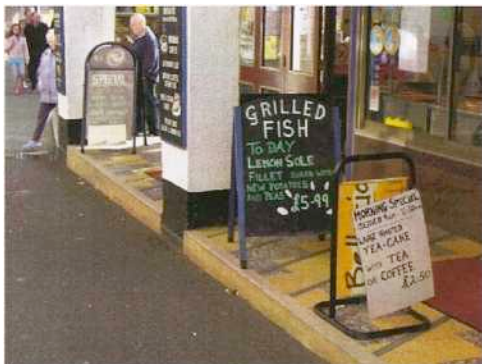
*Figs 38 & 39: Ad hoc signboards are scattered throughout Looe, which tend to clutter and undermine the aesthetic value of the historic environment. They are also a physical obstruction when the tight streets are full of visitors - especially for people with visual impairment.*

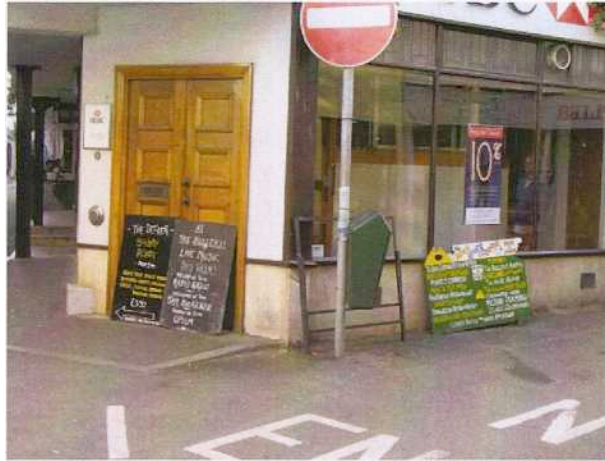
*Fig 40: The problem of portable temporary signs is so endemic in East Looe that some businesses think nothing of putting signs in front of other people's buildings. It has clearly taken some time for these practices to evolve and the perpetrators are probably oblivious to the negative impact. The way that visitors perceive a place is directly and subliminally affected by these discordant items; so ultimately all businesses are likely to be damaged by this clamour for attention*
